# ELEVATING AIRCRAFT RESCUE PLATFORM (Phase I) PRODUCT EVALUATION REPORT

12 February 1996

FINAL REPORT FOR PERIOD 14 APR 1995 - 5 JAN 1996

SUBJECT: Elevating Aircraft Rescue Platform Product Evaluation Report

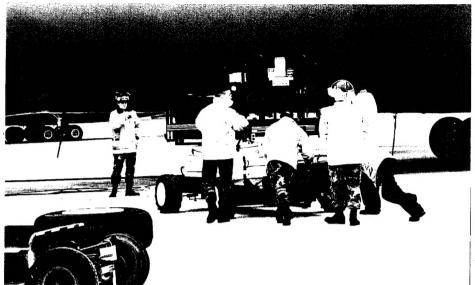
- (2). The time required to position the system varies depending upon how much equipment or spilled fuel might be in the vicinity, but would nominally require a couple of minutes. To manually position the 3,500 lb. platform near the aircraft required 6 firefighters, one third of the normal fire/rescue response contingency. The awkward body postures and movements by the personnel positioning the platform could lead to lower back injuries or strains.

Manual maneuvering Lift-A-Loft into position

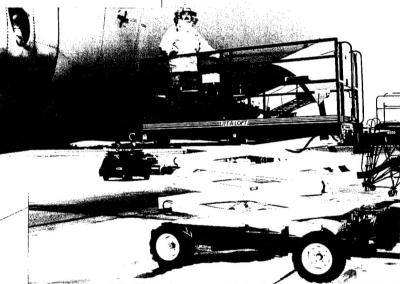
Lift-A-Loft near full extension

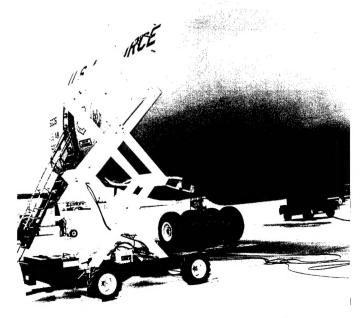
- (1). During the initial training scenario, with a wind of 12 knots, as the platform was being raised through 18 feet with two firefighters atop, the platform began to sway side to side, 8 to 10 inches off center. The 436th Wing Safety Office terminated the evaluation. This version of the Lift-A-Loft trailer does not have stabilizing outriggers. This was done deliberately to minimize set-up time and reduce tripping hazards around the base of the stand. The base is 45 inches wide and 111 inches long, the outriggers would extend 25 inches on both sides and add 5\(\exists \) inches beyond the front and back of the unit. The pavement of the Dover AFB parking ramp varies from level up to a 2% slope (2 feet of rise over a 100 foot run).
